## **Spring Creek Chapter TU - Grants and Habitat Projects 1999-2012 Author: Art Kempf, PhD**

### **Summary**

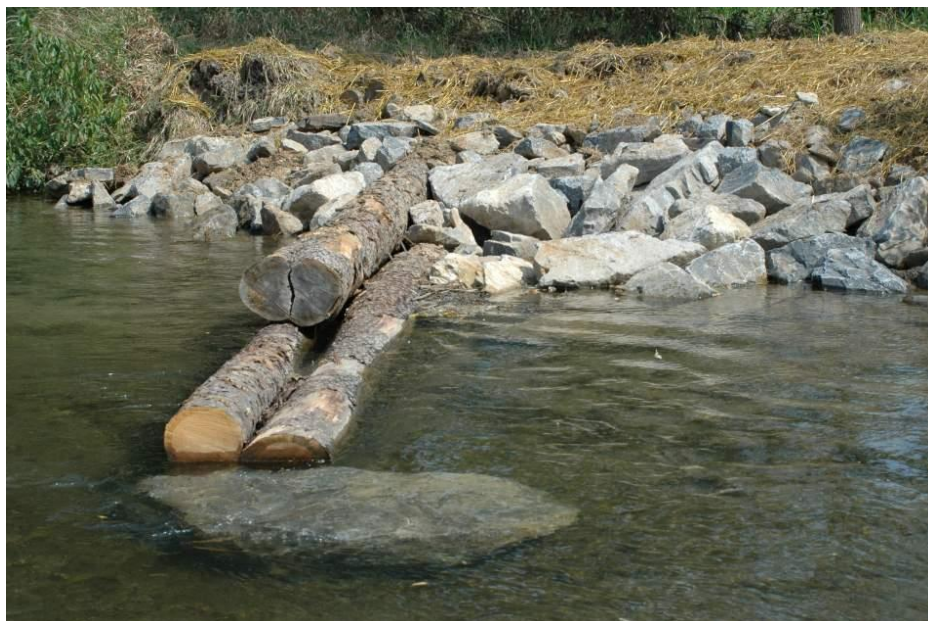
### **2007 - Sheep Farm Multi Log Vane Deflector**

The PSU Sheep Farm, located immediately downstream of Spring Creek Park was the first site selected for habitat enhancement work. Project work was completed in two phases during 2007 (phase I) and 2010 (phase II) at a total cost of \$60,600. The sheep farm was one of the most significantly impaired stretches identified on both the LSI and PADEP “integrated” lists and required both in-stream and riparian habitat enhancements. Years of degradation from farming practices and storm water surges from Slab Cabin Run had resulted in severe sedimentation and stream bank erosion in this stretch of stream. During phase I, a total of ten fish habitat enhancement devices including a 100ft mudsill, nine multi-log vane deflectors and 15+ random boulders were installed throughout a 1,300 ft. stretch of the stream. In addition, livestock fencing was moved away from the stream to create a 40-50 ft. riparian buffer. Approximately 400 trees & shrubs were planted in the spring of 2008 along the entire 2,700 ft. stretch of the PSU sheep farm property to enhance reforestation of the entire riparian zone. The project was a joint partnership between many stakeholders with additional funding received from CCCD (\$6,000 for fencing) and PSU (\$4,000 for fencing). The U.S. Fish and Wildlife Service provided equipment for relocation of fencing. Donations of equipment and professional staff supervision that were made by the PFBC were a significant contribution to completion of the project. CWC contributed grant monies and managed all phases of the riparian restoration efforts.

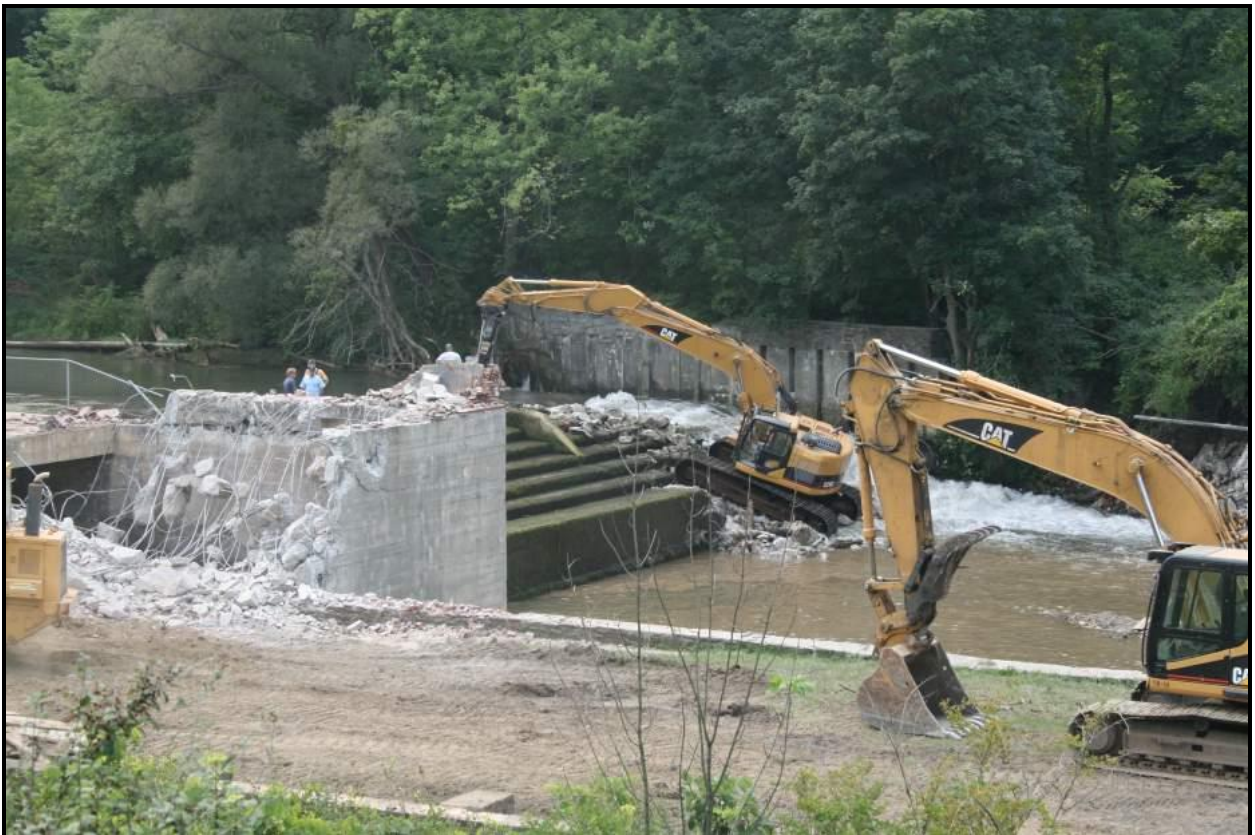
### **2007 - McCoy Linn Dam Demolition**

Following dam removal in 2007, habitat restoration was completed at the McCoy Site in two phases during 2008-2009 at a total cost of \$208,000. Prior to dam removal, the entire 2,000 ft stretch of Spring Creek was flooded by the 12ft high dam which not only prevented fish migration but also resulted in significant upstream habitat degradation due to accumulation of major sediment deposits and encouraged thermal heating of Spring Creek. The entire McCoy site was included on the LSI list, but surprisingly was not included on the DEP “integrated” list.

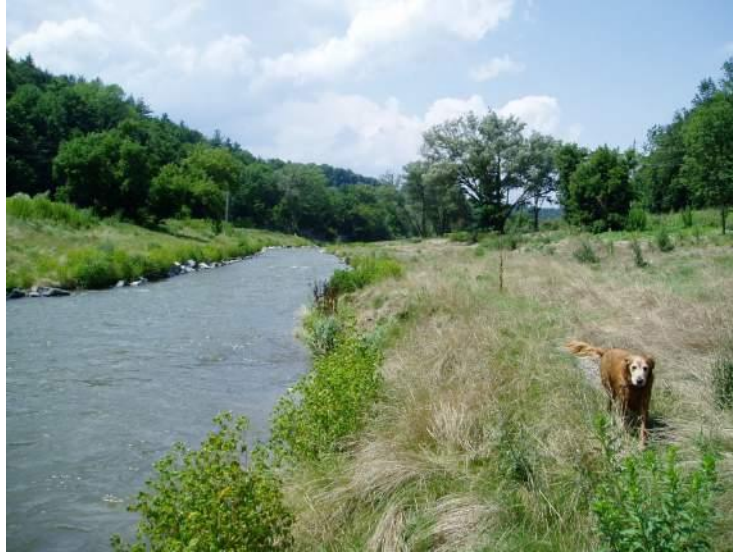
## 2008 - After dam removal, before habitat work

Phase I of the restoration effort was completed in 2008 and involved only limited in-stream work due to concerns that the stream bed channel had not yet stabilized in the stretch above the dam. In total, five devices were installed, three at the lower reaches near the (removed) dam base and two at the far upper reaches of the site. Two large rock vanes were installed (one on each bank) near the site of the former dam base to help stabilize the

channel. In addition, two small rock deflectors were installed on the west bank at the upper (South) reach of the site to stabilize severe bank erosion that was occurring near a wetlands runoff area. A large gravel bar (that had been deposited mid-stream directly below the location of the former dam base) was partially removed and re-positioned to guide stream flow toward mid-channel and the east stream bank. This was done in preparation for establishing a fishing/boating access ramp on the east bank (near the parking area). Some of the stone removed from the gravel bar was used to stabilize the fifth device, a small rock vane deflector that was installed on the west stream bank directly below the large rock vane. In addition, a gravel parking lot was constructed for improved public access.

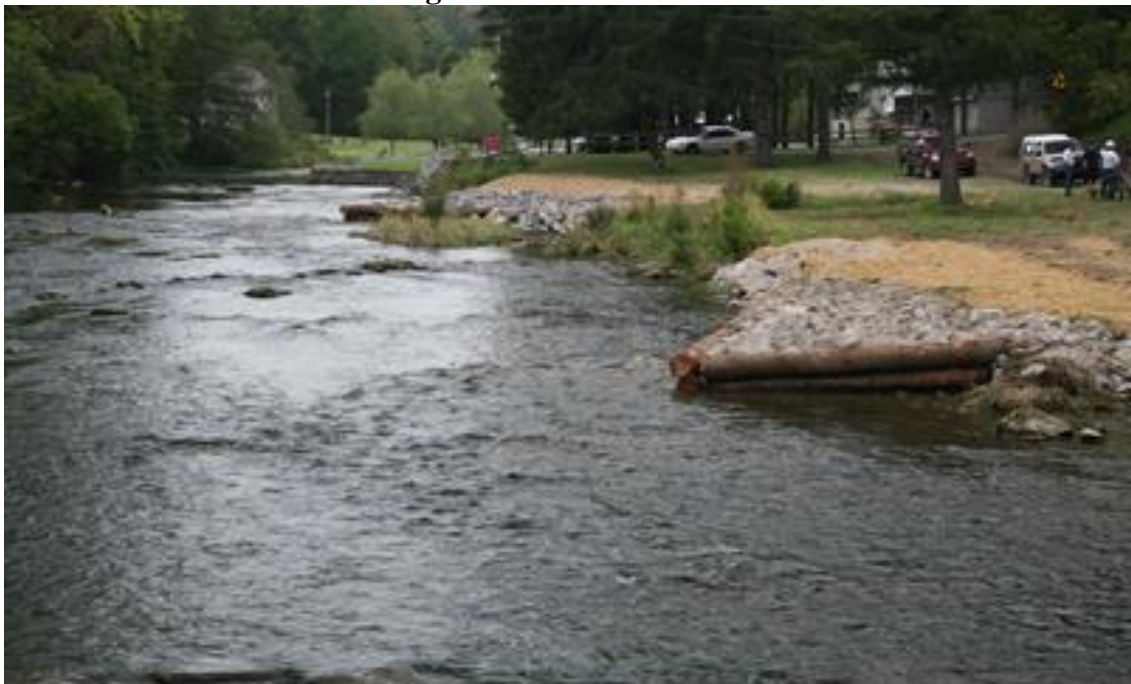
### 2008 - PBFC 550 “The Distillery” Log Faced Stone Deflectors

Following completion of McCoy phase I, habitat restoration efforts for 2008 shifted to the PFBC site located above SR 550 (“The Distillery” – See Above). This site was not identified on the LSI list, but significant erosion of the west bank was occurring that was not only removing significant amounts of the west bank but was threatening to undercut the footbridge located in the middle of the stretch. Habitat work was completed by SCCTU volunteers in partnership with PFBC and CWC at a total estimated cost of \$25,800. A total of four devices were installed over a 600ft stretch. Two large log faced stone deflectors, one improved overhead cover stone deflector and a stone deflector were installed on the west bank of the stream. At least 30 large boulders were also distributed in-stream for habitat creation. Riparian planting of 200 trees and shrubs was completed in fall 2008 by SCCTU and other volunteers under the supervision of CWC.

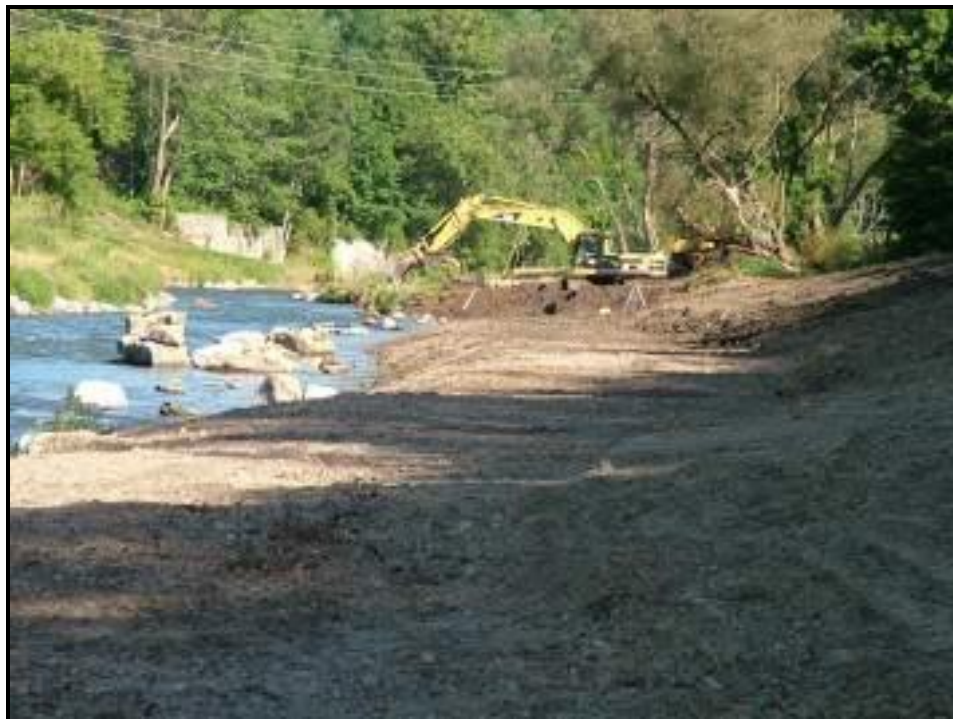
### **2009 – Restoring Stream to Natural Dimensions at the McCoy site and creating a Floodplain Bench**

Phase II, the most significant phase of the habitat enhancement project was completed during 2009 and consisted of creating a flood plain bench on the east bank to help dissipate energy during high flow events; installation of 69 devices including 4 large rock cross vane structures, four large mudsills, multiple multi-log and rock vane deflectors and 27 root wads (added for enhanced habitat creation). In addition, more than 60 large boulders were randomly distributed in-stream for habitat enhancement. The entire 2,000 ft east bank of the restoration site was professionally planted with 840 native trees and shrubs during fall 2009. A significant portion of the funding and supervision for the riparian work was provided by CWC.

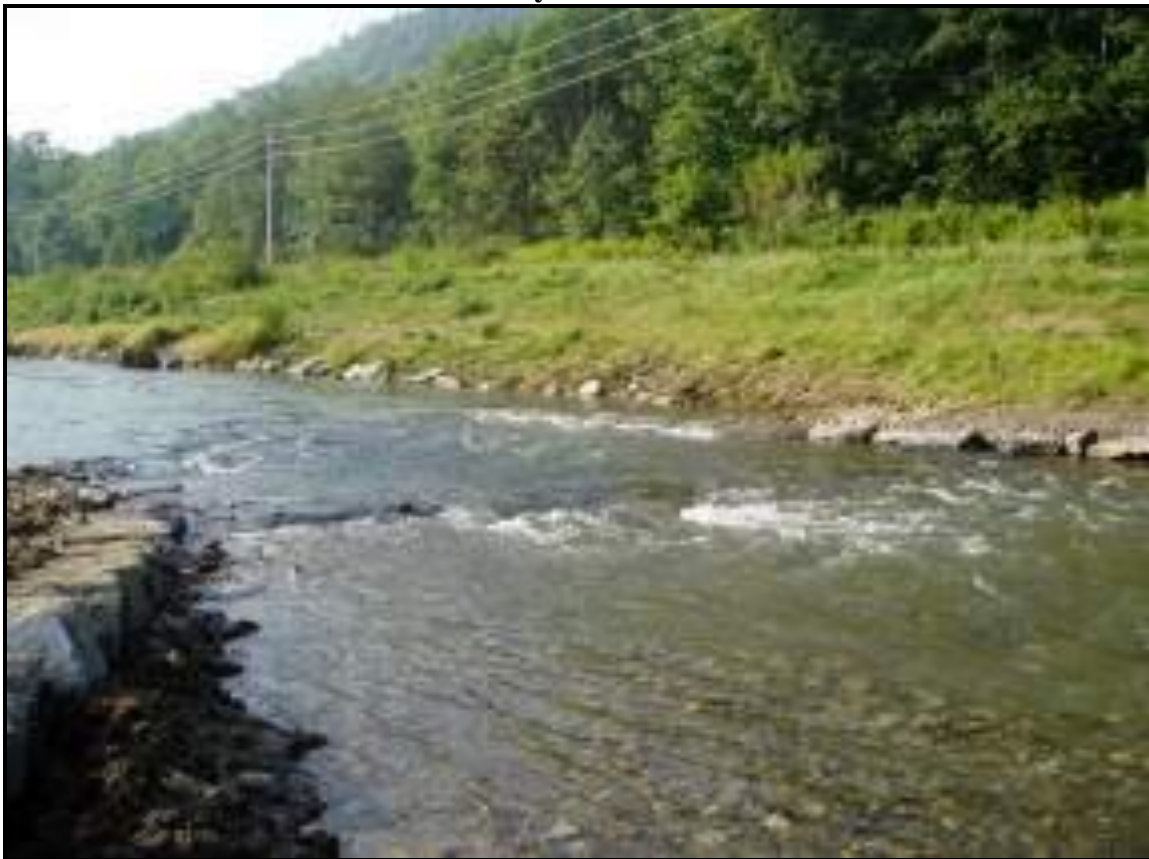
### **2009 - McCoy Rock Cross Vane**

This was the first Spring Creek habitat enhancement project that utilized large rock cross vanes for habitat creation and water flow management (similar, but much smaller rock cross vanes were utilized in Buffalo Run and Slab Cabin Run projects). Utilization of this technology at McCoy was necessary due to the relatively high gradient and flow velocity in this stretch. Structures of this type are effective in directing flow toward the middle of the stream channel, provide run/scour pool habitat, and also dissipate some of the kinetic energy of the water, thereby reducing flow velocity. The result is reduction of stream bank erosion, especially during high flow conditions. In-stream work during Phase II of the McCoy project was completed with support from PFBC, Gleim Environmental Inc., WHM Consulting and volunteers from SCCTU and the community.

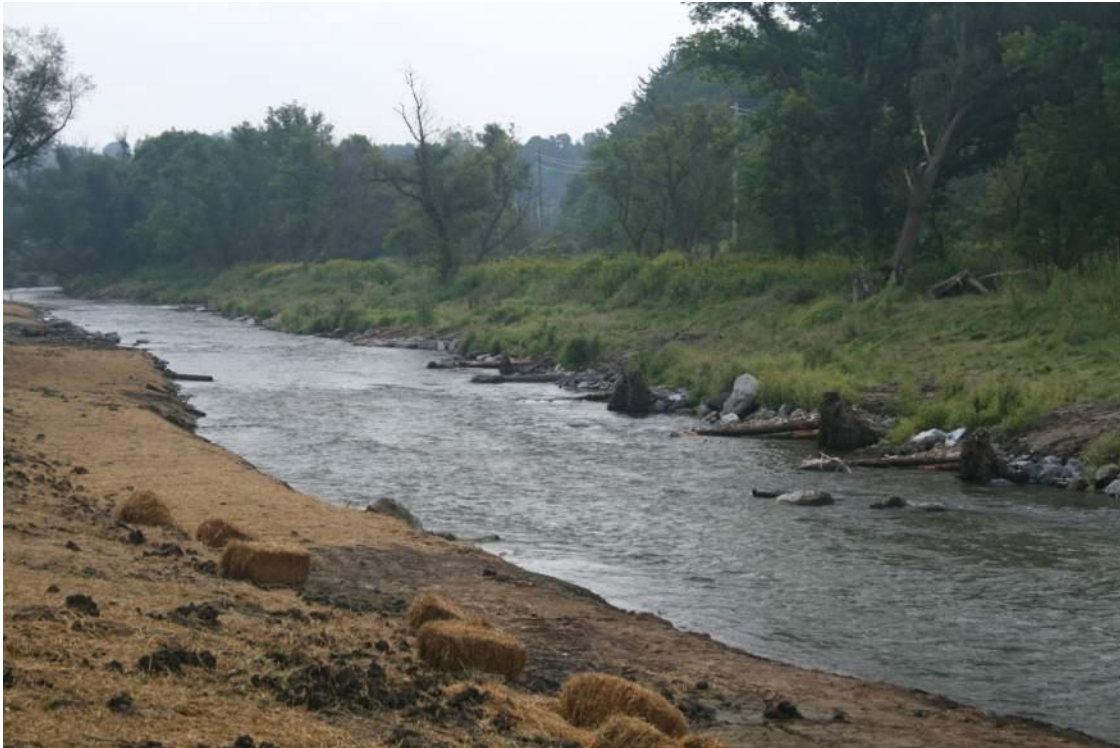
### **2009 - McCoy Multi Log Vane Deflectors with Root Wads**

Another first for a Spring Creek habitat project was the inclusion of root wad devices into rock and log vane structures at McCoy for additional stream bank erosion protection and incremental habitat creation. A total of 27 root wads were installed along the west stream bank in various arrangements typically located in grouping of 2-3 wads, positioned directly downstream of a log or stone vane device. This application seemed especially appropriate for utilization in this relatively wide-open stretch of stream where overhead protection of the trout is desired.

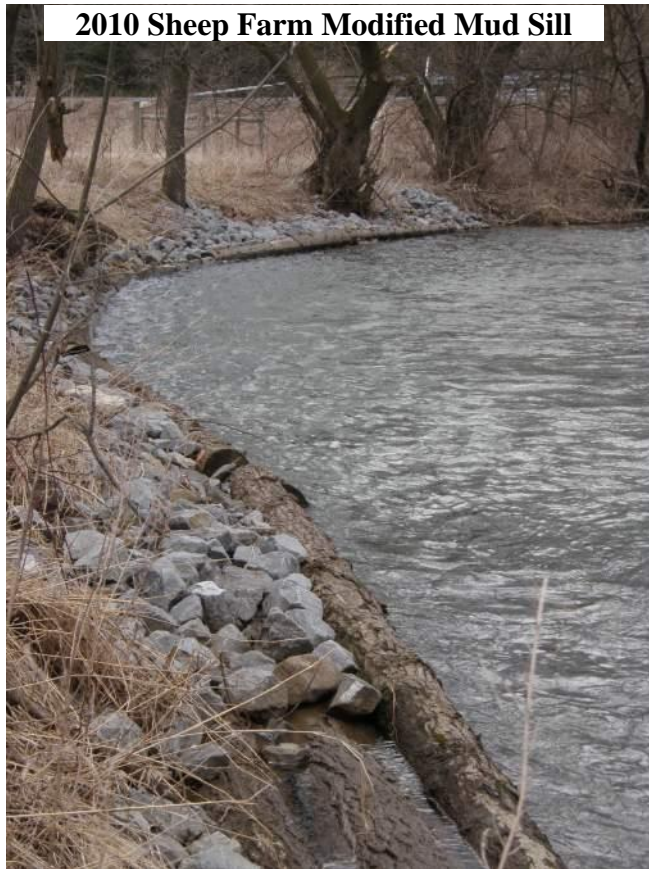
**2010 Sheep Farm Modified Mud Sill**

The PSU Sheep Farm phase II was completed simultaneously with habitat restoration activity at Spring Creek Park. Five devices including a large 150 ft modified mud sill were installed in this 1,400 ft stretch. The modified mud sill was installed on the east bank directly below the Puddinton Rd. bridge to remedy a significant erosion problem

occurring at that location. Because of its design it will also provided excellent habitat for trout. The remaining four devices were installed directly above the PSU sheep farm bridge and included; one log faced rock deflector and one rock deflector on the east bank and two small rock deflectors on the west bank. This completed all habitat enhancement work at the PSU Sheep Farm. Riparian buffers had been widened and planted, fencing installed and in-stream structures installed for erosion control and habitat enhancement along the entire 2,700ft stretch of the farm.

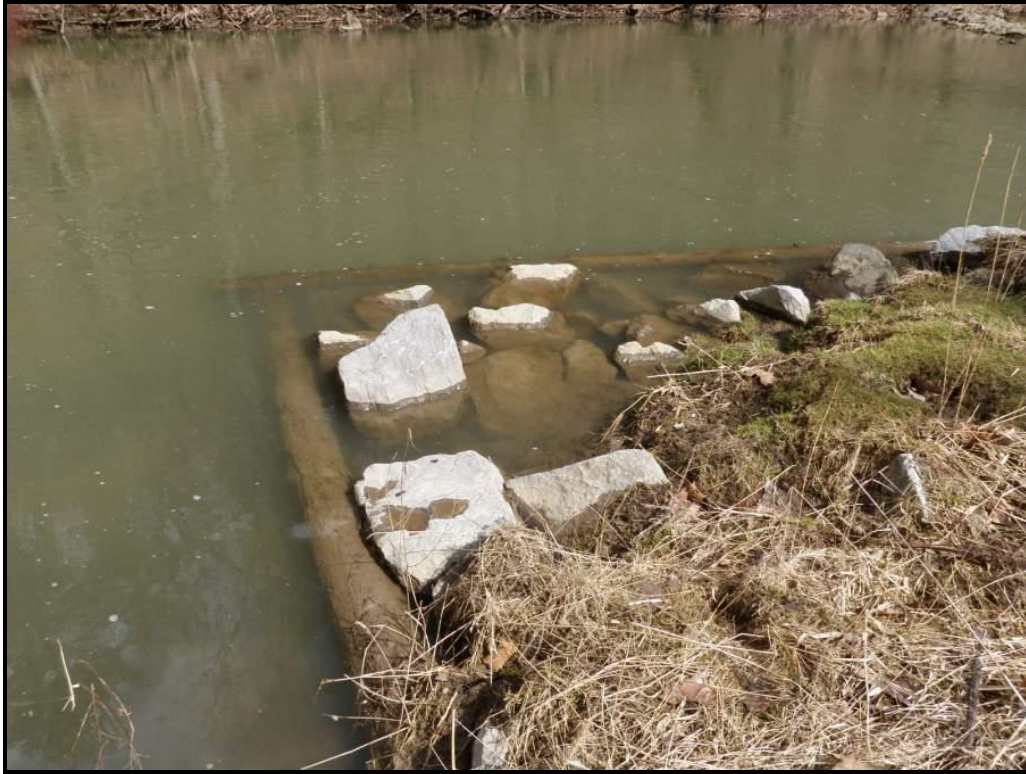
## 2010 - Fisherman's Paradise Stacked Stone Log Faced Deflector

The final restoration project for 2010 was completed in the Stackhouse section of Fisherman's Paradise and consisted of installation of three multi-log vane deflectors and one stacked stone log faced deflector. These devices were added to the

west side of the stream at a location just upstream of the regulated no-wading section. More than 20 large boulders were also distributed for habitat creation in this stretch. In addition, four brush fills (utilizing cut willow branches) were installed downstream of existing deflectors and walls (in reaches just above the Stackhouse parking lot) to trap sediment and encourage formation of stabilized stream banks at these locations. Some work was also done to repair a few existing habitat structures below the foot bridge. In total, habitat enhancement/repair was done on approximately 1,100 ft stretch of the Fisherman's Paradise. Total cost for completion of the work by SCCTU volunteers and PFBC supervision is estimated at \$6,700.

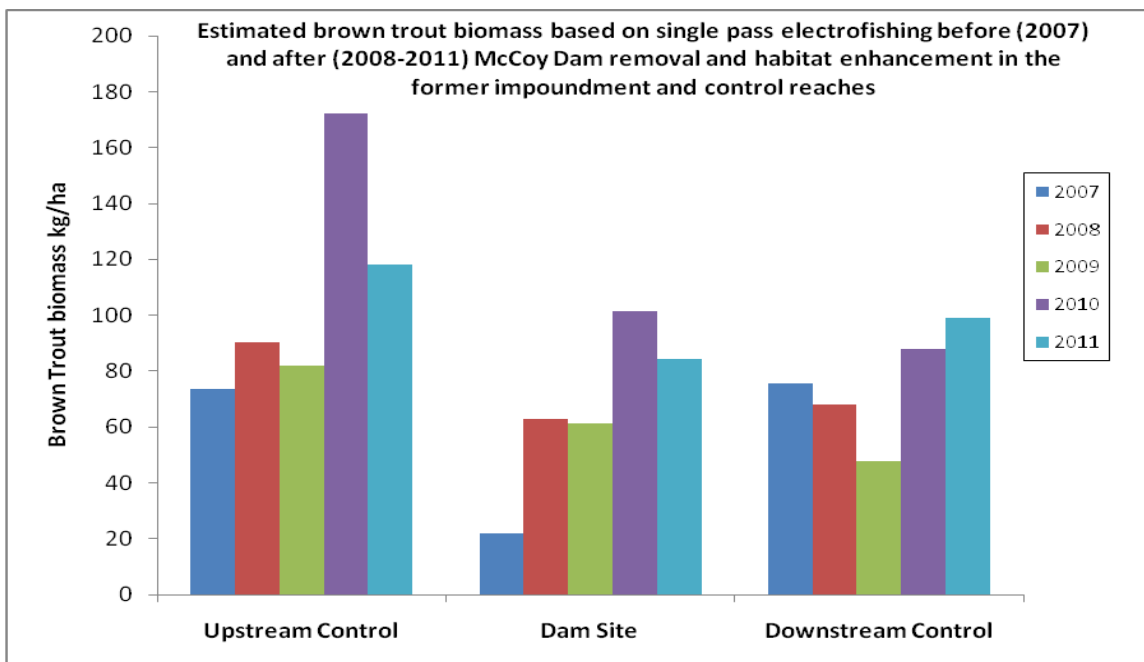
Figure 4. Brown Trout Response to the Improved Habitat at the McCoy Site

In addition to riparian restoration efforts during 1999-2012, a significant amount of SCCTU effort was directed toward in-stream habitat enhancement and stream bank stabilization, creating improved spawning and adult trout habitat. Results of biological monitoring have confirmed the positive benefits of the projects. Brown trout redd count data has been collected by the Pennsylvania Cooperative Fish and Wildlife Research Unit and PFBC since 1987 indicates that since around 2000 a considerable increase has occurred in the total count of redds in Spring Creek (Milesburg to SR 45 bridge in Boalsburg). Annual redd counts increased by 70% from 1,009 to 1,797 counts during this period (data from PFBC, J. Detar). This included a two fold increase in redds at the Sheep Farm site after the habitat enhancement project was completed. Additionally, the PFBC's monitoring of the brown trout population at the McCoy site (Fig 4) showed that biomass increased three-fold following the removal of McCoy Dam and follow-up instream and riparian habitat restoration. These are positive indications that the collective efforts to reduce sedimentation loads, improve water quality, and enhance physical and riparian habitats in the watershed have resulted in improved habitat for brown trout.
